1. REPORT DATE (DD-MM-YYYY) 270504		2. REPORT TYPE Final Report		3. DATES COVERED (From - To) 15 Sep 2000 - 14 Mar 2004	
4. TITLE AND SUBTITLE Detection of Incipient Metal Corrosion and Cracking Beneath Paints Using Near Infrared Ultrafast Photonic Techniques				5a. CONTRACT NUMBER	
				5b. GRANT NUMBER F49620-00-1-0378	
				5c. PROGRAM ELEMENT NUMBER

FINAL REPORT
FOR AFOSR GRANT # F49620-00-1-0378
(CUNY RF 47435-00-01)
Period Covered: 9/15/00 – 3/14/04

The objective of this research project is to test the concept of a nondestructive and noninvasive optical method to determine metal corrosion and cracks underneath paint layers using infrared spectral polarization imaging.

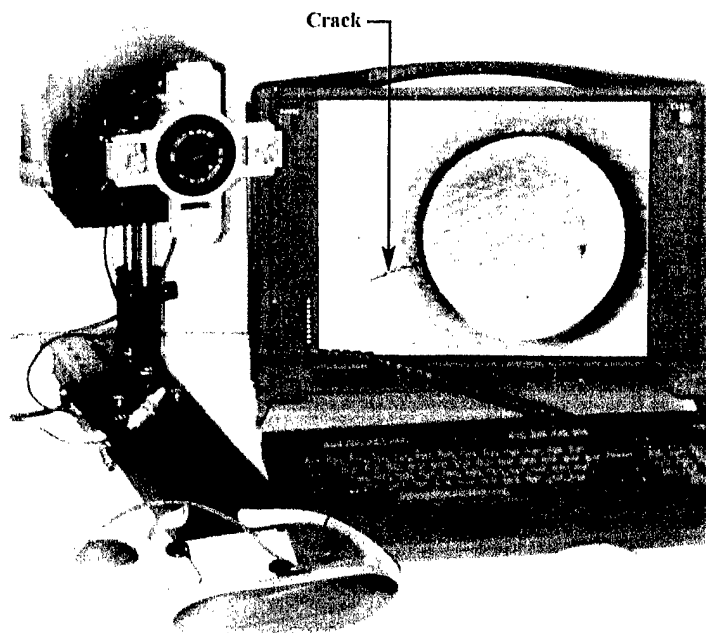
Rapid Acquisition Surface Inspection System (RASIS)

The Non-Destructive Inspection RASIS system is a real-time hand-held or robotic mount imaging system that can image through paint for inspection of aircraft micro-cracking around rivet heads or the upset end, and the detection of the earliest stages of surface corrosion beneath surface paint layers.

RASIS will detect a micro-crack <.060 inches emanating from an aircraft rivet head with greater resolution than existing competing technologies. RASIS is a simple to use, fast, real-time imager that utilizes a narrow optical window, polarizers and illumination source which permits high resolution inspection of the metal surface beneath the paint. Due to a 0.5 inch viewing area in a single frame, high frame rates and predetermined focal length, inspections can be accomplished rapidly along a structure.
